## **APPLICATIONS FOR MOTOR CURRENT SIGNATURE ANALYSIS**

**An ALL-TEST Pro White Paper By**

**Howard W Penrose, Ph.D.  
General Manager  
ALL-TEST Pro  
A Division of BJM Corp  
123 Spencer Plain Rd  
Old Saybrook, CT 06475**

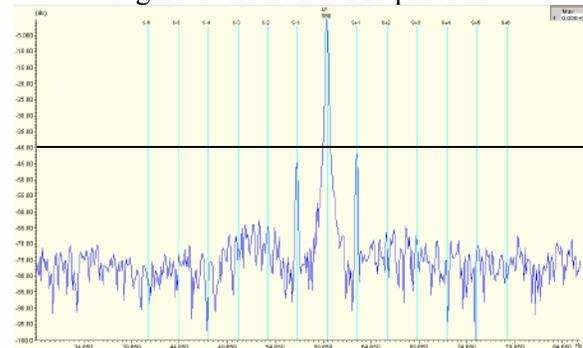
Figure 1: Rotor Bar Frequencies

The example in Figure 1 shows sidebands at about -40 dB from the peak line frequency. This would indicate at least one fractured rotor bar in this 500 HP, 4160 Volt motor on a compressor.

The fundamental purpose behind the original development of MCSA technology was the detection of rotor bar faults. Rotor bars are difficult to assess using traditional test methods, including vibration analysis. It was determined that a method using current could be used to evaluate the condition of the rotor bars. The basic rule is simple: Pole pass frequency sidebands around the fundamental line frequency, when the motor is under load, indicate problems with the rotor. The standard rule has been determined that rotor bar issues are serious when the sideband peaks approach to within 35 dB of the line frequency peak.

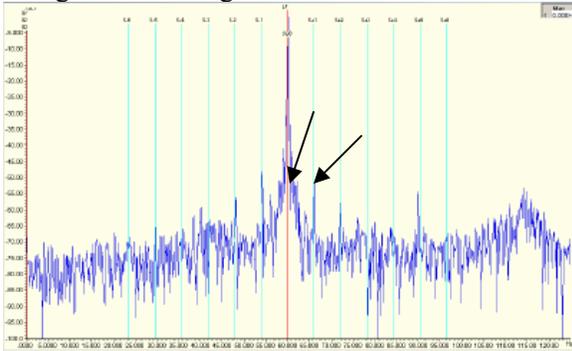
Figure 2: Casting Void or 'Soft' Gear Tooth

Figure 2 is an example of one of two possible scenarios:

- ✓ Casting voids in an aluminum rotor.
- ✓ Soft tooth (or teeth) in a geared application.

As you will note in Figure 4, peaks are identified in current, but do not show in the voltage FFT. This indicates that mechanical faults exist. As they relate to the running speed and the number of stator slots, it is a mechanical fault related to the windings. Several other current-only peaks exist, indicating load-related faults, in this case, most likely a gearbox problem (note that this is the high-frequency data related to Figure 2).

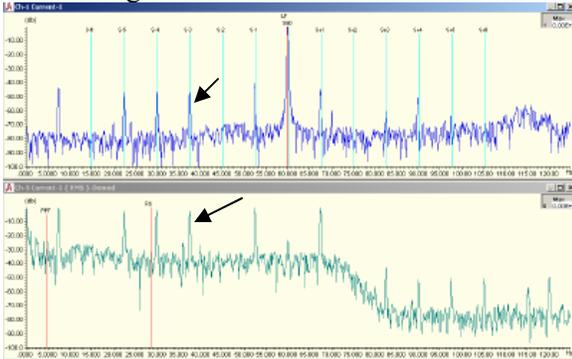
Figure 3: Rotor Rub at No Load

The data in Figure 3 relates to a 7.5 horsepower, 1800 RPM, submersible pump tested dry at no load. The rotor was rubbing slightly against the stator core which was identified as static and dynamic eccentricity with multiple current peaks as shown.

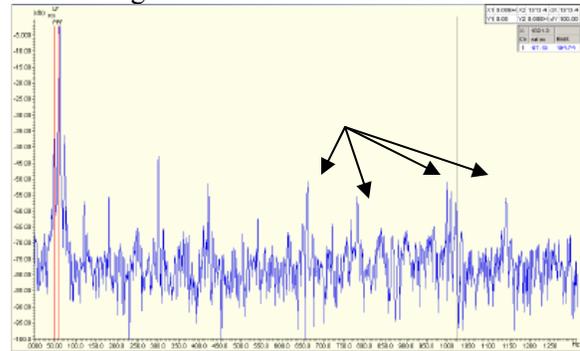
Figure 5: Mechanical Unbalance

The motor shown in Figure 5 had a mechanical unbalance. The signature shows up as a twice line frequency (LF), four times line frequency (LF), then twice line frequency pattern. In this case, rotor bars times running speed with LF sidebands then the remaining pattern appears.

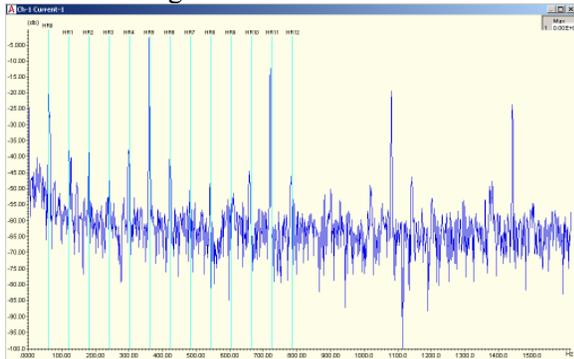
Figure 6: DC Drive Fault

In the case of Figure 6, multiple harmonics of line frequency plus multiple harmonics of the number of power electronics (SCR's) times line frequency (360 Hz, in this case), indicates an SCR fault or loose connection. This can be confirmed by viewing the voltage and frequency ripple in the low frequency data.

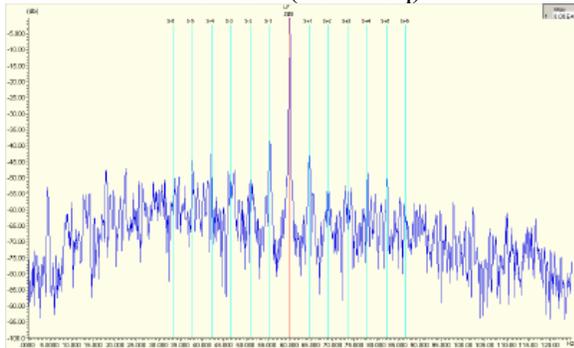
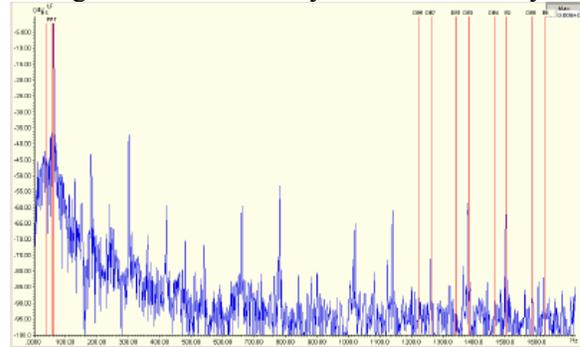
Figure 7: MCSA Data on Synchronous Alternator (Low Freq)

The alternator being tested showed an increase to eccentricity over a 40 minute test run, rotating field faults and some electrical fault signatures. This information was coupled with MCA data which indicated a winding short, a cable short and a significant drop in insulation resistance over the short part-load run.

Synchronous alternators can also be evaluated quickly and simply using voltage and current demodulated current. In the case of the following example, an alternator tripped on high temperature. Both MCA and MCSA were used to evaluate the system.

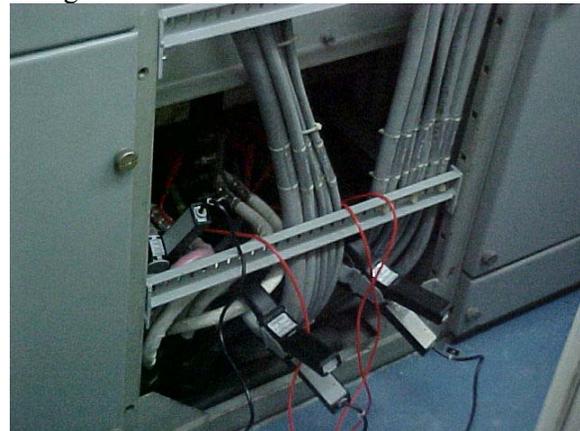
Figure 9: Current Connection for Alternator

The alternator was a 475 kW, 480 Vac alternator which required three parallel cables per phase. There are a number of options with the ATPOL system for larger cables. However, in a pinch, one of each of the three cables of each phase was used, so the current values were roughly 1/3<sup>rd</sup>.

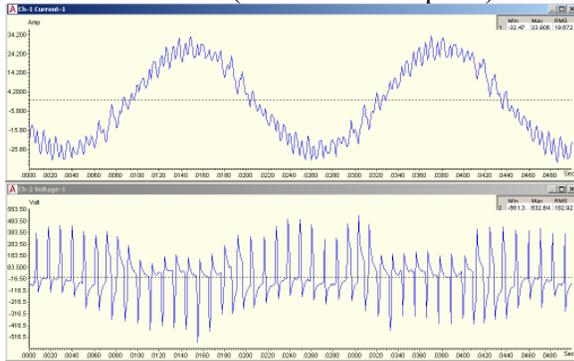
Figure 10: VFD Voltage and Current Waveforms (0.05 Second Capture)

Variable frequency drives have been a challenge for a number of MCSA systems. In the case of the ATPOL, however, this is not a problem. The output voltage and current signals can be viewed (Figure 10).

In Figure 11, which is the Low Frequency (<120 Hz) data for the same system as Figure 10, shows that the output line frequency of the drive is 43 Hz and the operating speed of the 3600 RPM motor is 2570 RPM.

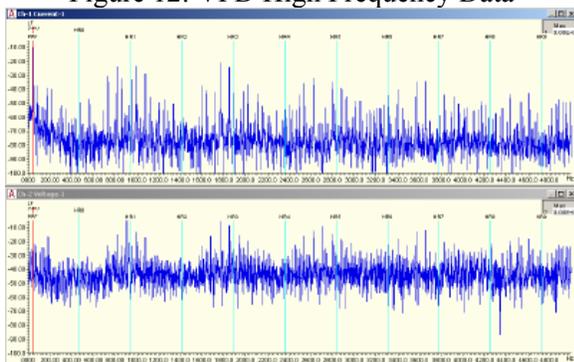
Figure 12: VFD High Frequency Data

As can be noted in Figure 12, strong voltage and current peaks indicate motor system related faults. Some of the additional noise is strictly due to the voltage and current waveforms that come from the VFD. However, the software

will automatically place cursors related to different faults within the waveforms.

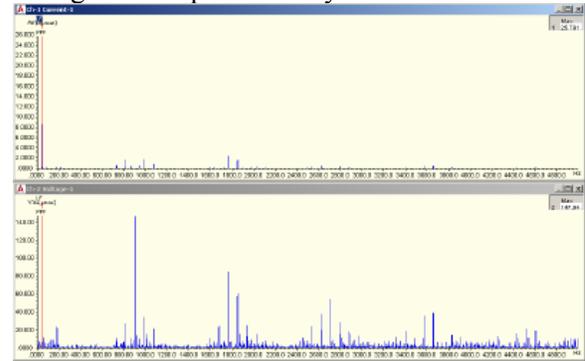
Figure 13: Special Analysis in Peak Values

Figure 13 shows the same data, but with the peak voltages and currents shown. The higher frequency currents indicate issues related to the voltage harmonics, which are shown in the lower waveform. All data combined shows an incoming voltage related issue. When tested at 46 Hz, the problem became more significant and pointed to a potential fault with the supply system that becomes prevalent above 45 Hz. The solution would be alleviated with filtering applied to the VFD drive output.

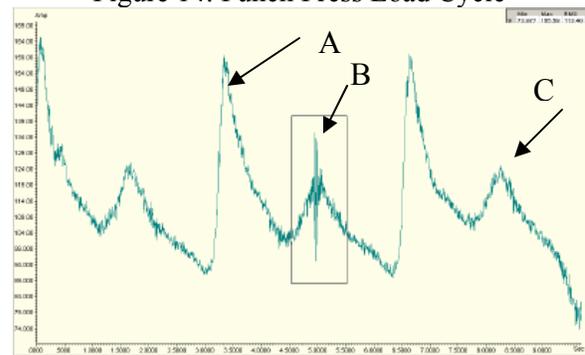
Figure 14: Punch Press Load Cycle

Figure 14 shows the current cycle over 10 seconds. Peak A is one of three peaks in this cycle that relates to the punch (bottom) of the press stroke while point C is related to the top of the stroke. Point B identifies some type of

rubbing or grabbing problem as the system approached the peak of the stroke. The three bottom strokes help identify that the operation is occurring 18 times per minute.

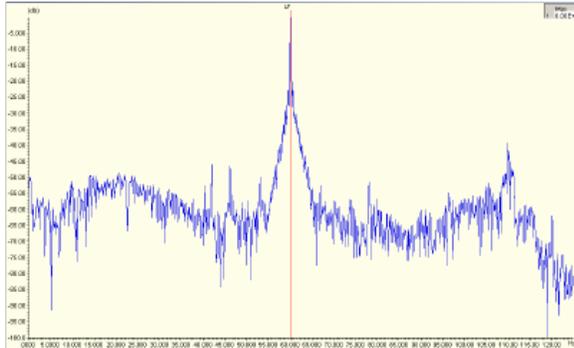
Figure 15: Motor-Related Line Frequency Sidebands

Figure 15 identifies a high 'noise floor' and many sidebands around the peak LF frequency. This, along with the high frequency data, assists in pointing the direction towards the load.

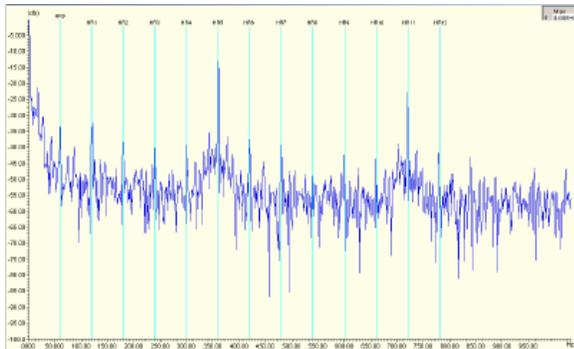
Figure 16: Eddy-Current Clutch High Frequency Data

Figure 16 identifies that a connection and/or SCR fault exists in the supply DC voltage from the rectifier (six SCR's). The peaks in the high frequency spectrum also identify faults in the eddy-current drive and the punch press itself, most likely looseness in the system (related signatures show raised noise floors).
