**ALL-TEST Pro  
Case Study 2004-002**

**Motor Current Signature Analysis on Gearbox Motor**

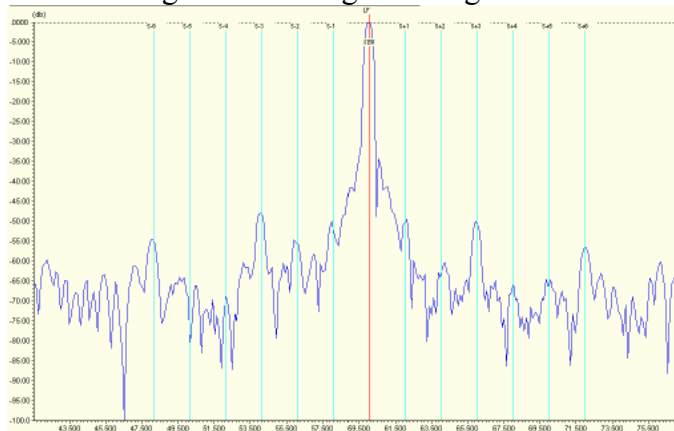
Figure 1: Casting Void Signature

Although lightly loaded, the ATPOL automatically identified casting voids (Figure 1), an electrical fault in the stator (Figure 2), gear problems and identified the number of rotor bars (48) and stator slots (36).

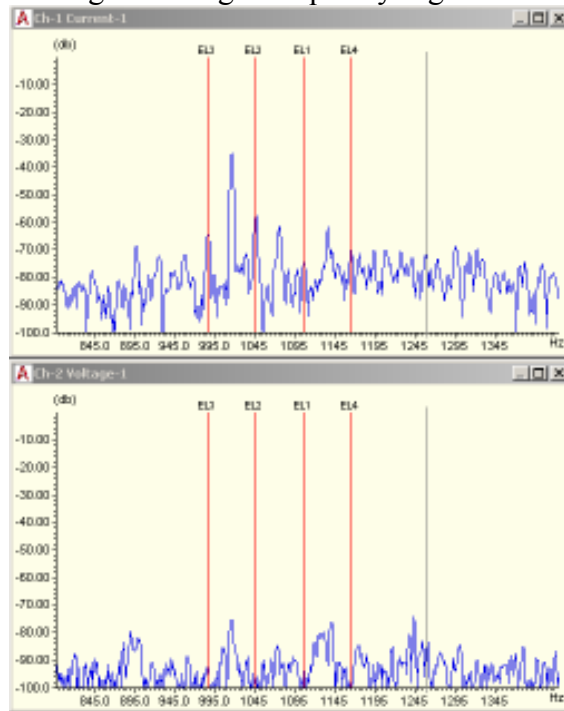
Figure 3: Auto-Analysis Form and Report Page

Figure 3 shows the automatic analysis display shown in the ATPOL software.

Calculations				
Time	Freq.	Bearings	Phasors	Results
Power factor				PF is below 0.85
Current				OK
Voltage				Dev. too much from name plate
Load				OK [Ld:34.2%]
Vlt-GND ref. NDT neutral				OK
Connection				OK
Rotor				RB health is questionable [C:7]
Stator				Elec. Mech.
Air gap				OK
Harmonic distortion				OK
Misalignment				OK
Bearing				OK
Bottom line				Abnormal indications
